### REPORT ON OBSERVATIONS AT THE BATH VILLAGE BRIDGE BATH, NEW HAMPSHIRE

**JAMES L. GARVIN**  
**SEPTEMBER 18, 2008**

This report is based on observations made at the Bath Village Bridge on September 16, 2008. The inspection was made as part of a broader bridge evaluation by Sean James and Josif Bicja of Hoyle, Tanner & Associates, consulting engineers, assisted by crew members from Wright Constriction Company of Mount Holly, Vermont. The purpose of the Hoyle, Tanner inspection was to provide an update to their submitted in April 2006. The purpose of the Division of Historical Resources' inspection was to determine the condition, integrity, and evolution of the bridge in order to be prepared to apply the *Secretary of the Interior's Standards for the Treatment of Historic Properties* in any future review of proposals for treatment of the bridge.

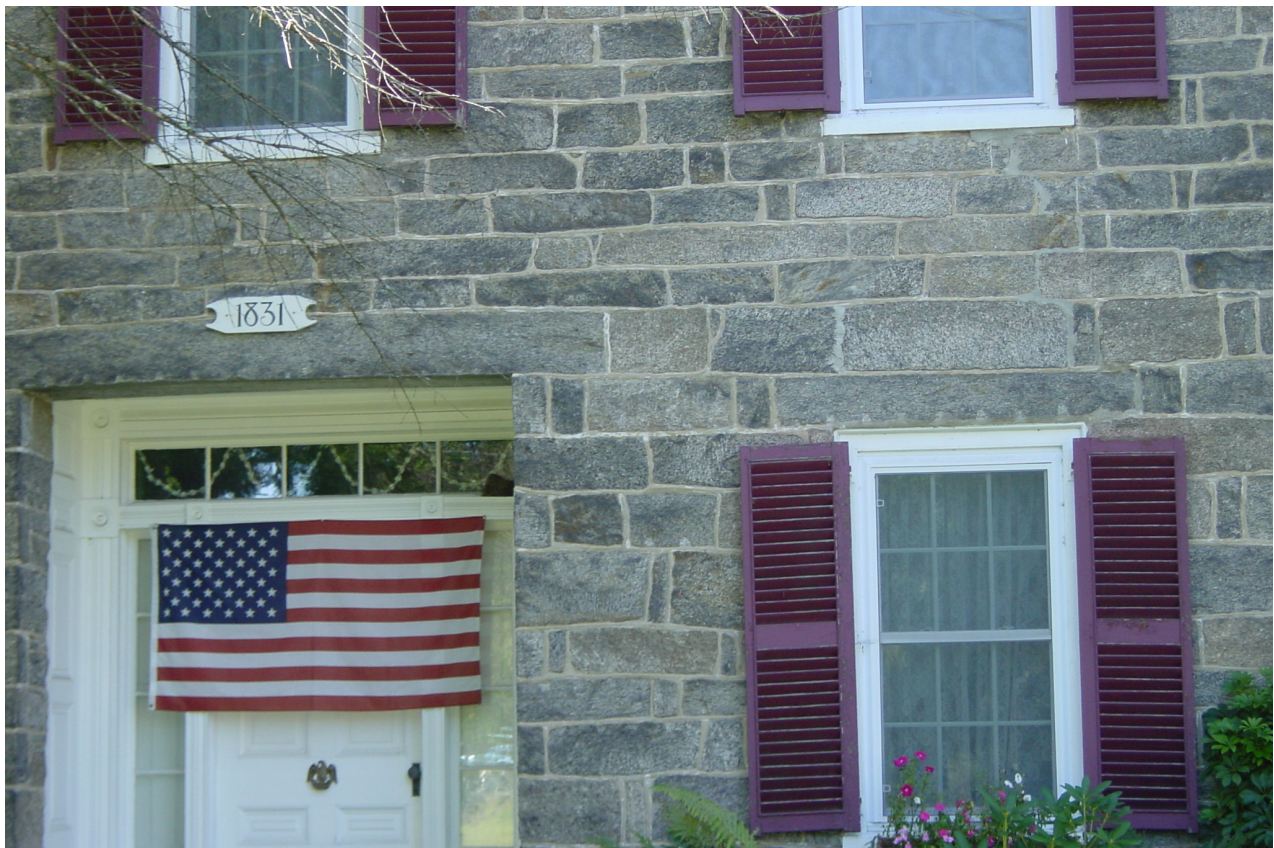
The fact that flat-wedge granite splitting was still being used in Bath in 1831, the year in which the two original piers were built, is verified by the William Vance Hutchins House, a granite dwelling of 1831 that stands a short distance from the bridge. As seen above the doorway and window in the photograph below, the walls of this building clearly show evidence of flat-wedge splitting.

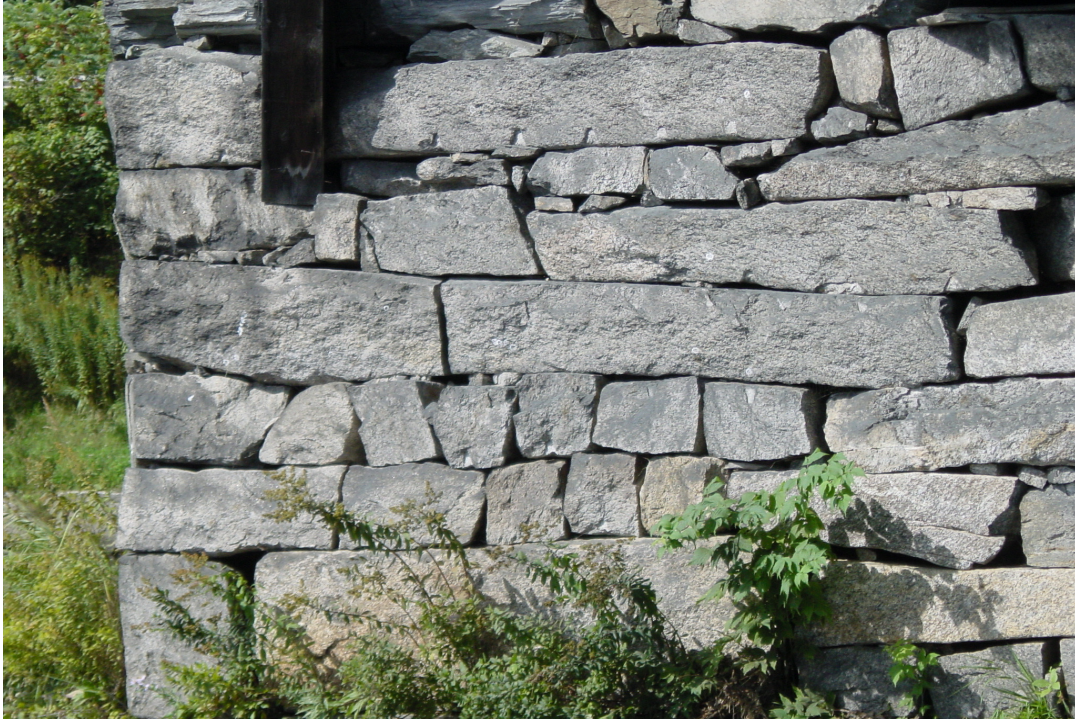
**Detail of east face of Pier 2, Bath Village Bridge**

The same splitting technique is clearly visible in both Pier 1 and Pier 2 of the Bath Village Bridge.

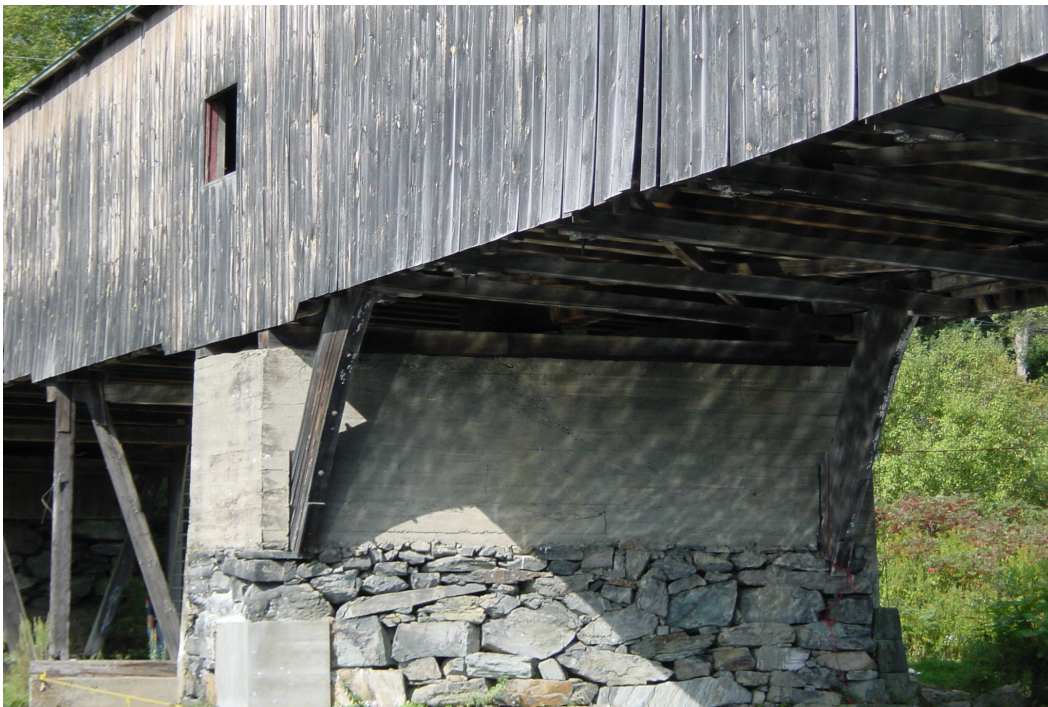
**East face of Pier 3, Bath Village Bridge**

By contrast, Pier 3 has fewer large split stones than Piers 1 and 2:

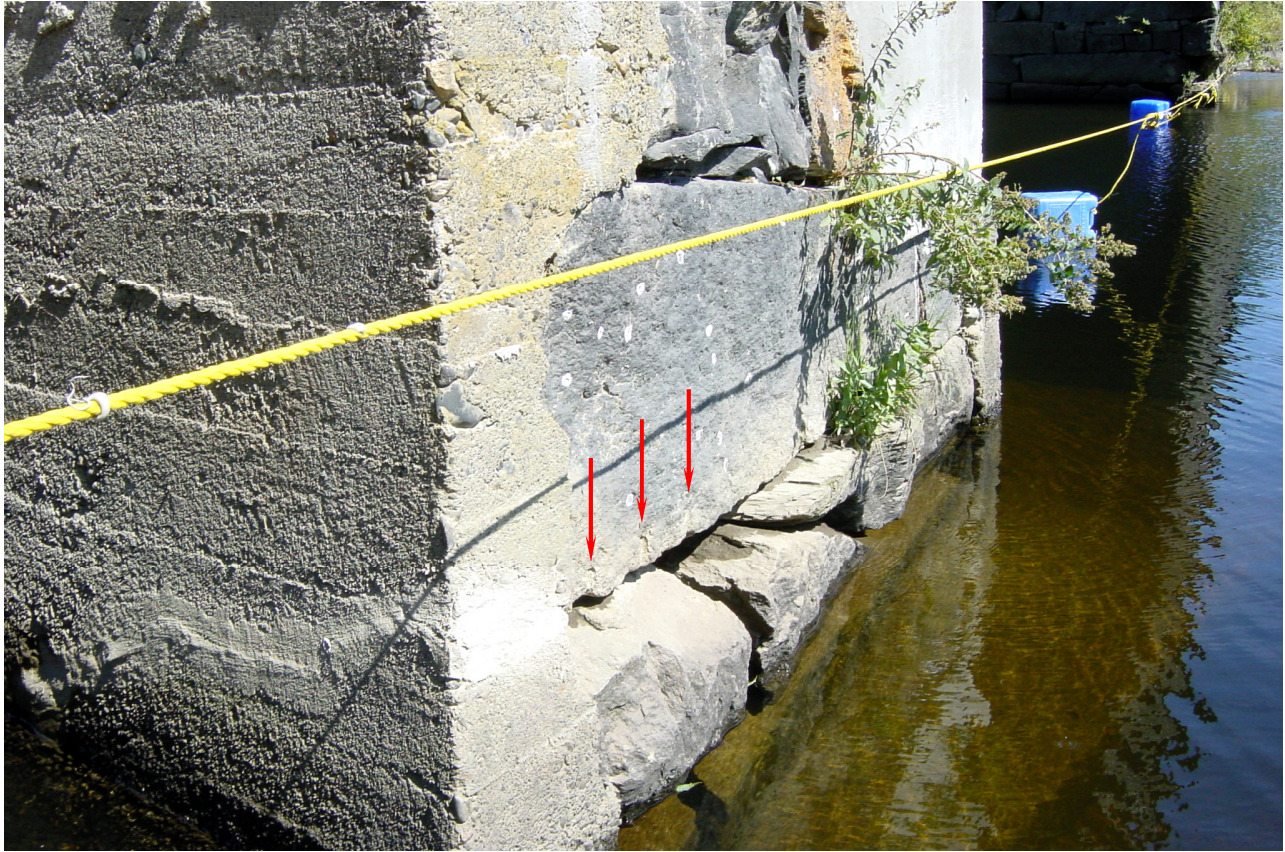
**South face of Pier 3, Bath Village Bridge**

While Pier 3 shows less evidence of splitting techniques, one of the lowest stones in this pier, clearly original, displays the marks of the plug drill, denoting its later date:

Although stone splitting evidence confirms the long-held belief that Pier 3 was added beneath the center of Span 3 after completion of the bridge, this physical evidence cannot suggest how much later the pier was added. Because the flat-wedge method of splitting granite was supplanted by the plug-and-feathers method soon after the bridge was built, Pier 3 could date anywhere from a few years after completion of the span up to around 1910, when concrete supplanted stone masonry for most work. Although the stonework of Pier 3 is too crude to suggest railroad construction of the latter nineteenth century, it is possible that this pier was added to the bridge when tracks first passed under the bridge in 1852-3. It is possible that this pier was not originally built to the height of the others, but that it supported a wooden trestle that extended up to the bottom chords of the bridge.

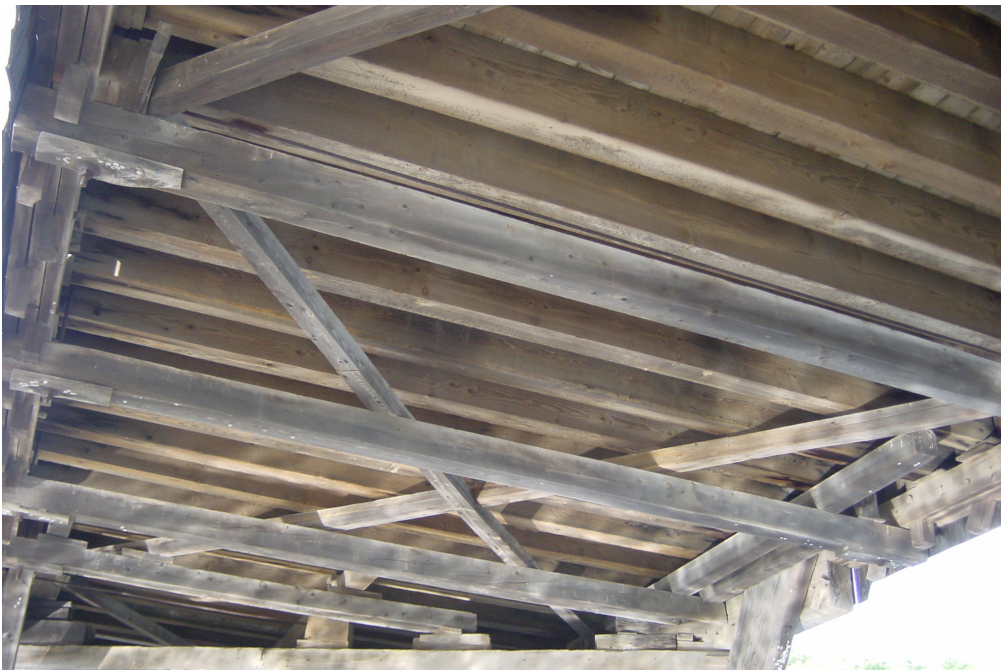
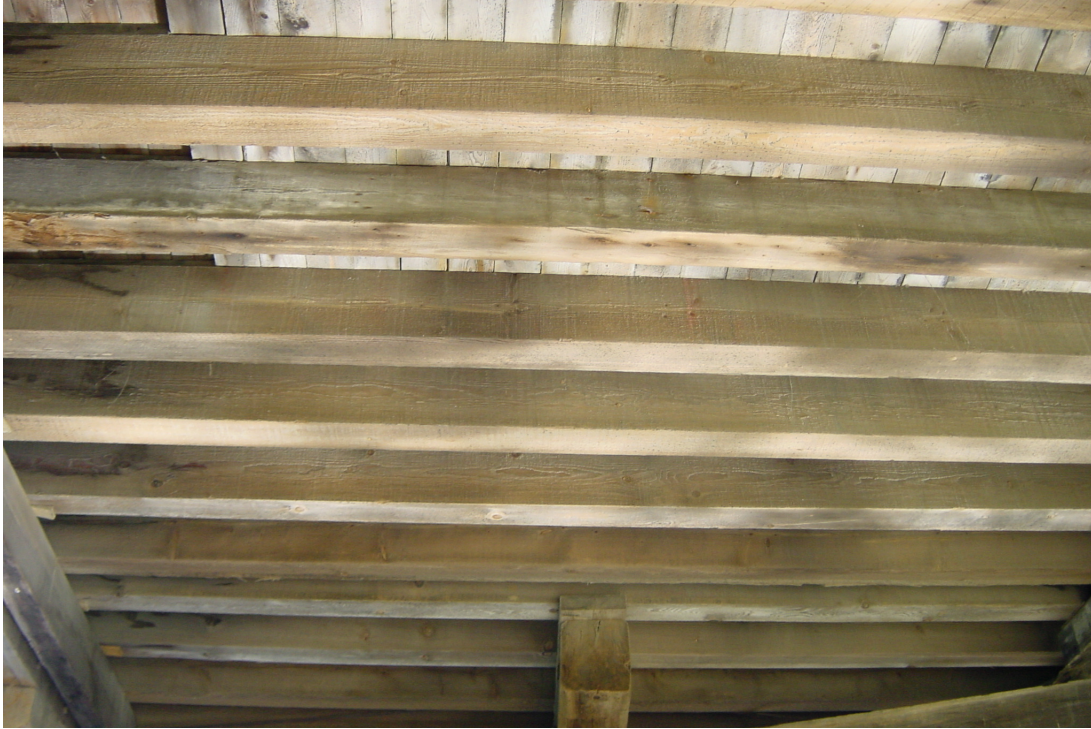
Observations made from the available vantage points suggest that all of the floor beams now in the bridge are of recent date. Some existing beams appear to predate the rehabilitation of 1987-88. Those beams that were found to be sound in 1987-88 appear to have been turned over to allow new floor planking to be nailed into the sound wood of what had been the bottoms of the beams.

The majority of beams now seen in the bridge, however, appear to have been installed in 1987-88 above older needle beams and lower lateral bracing:

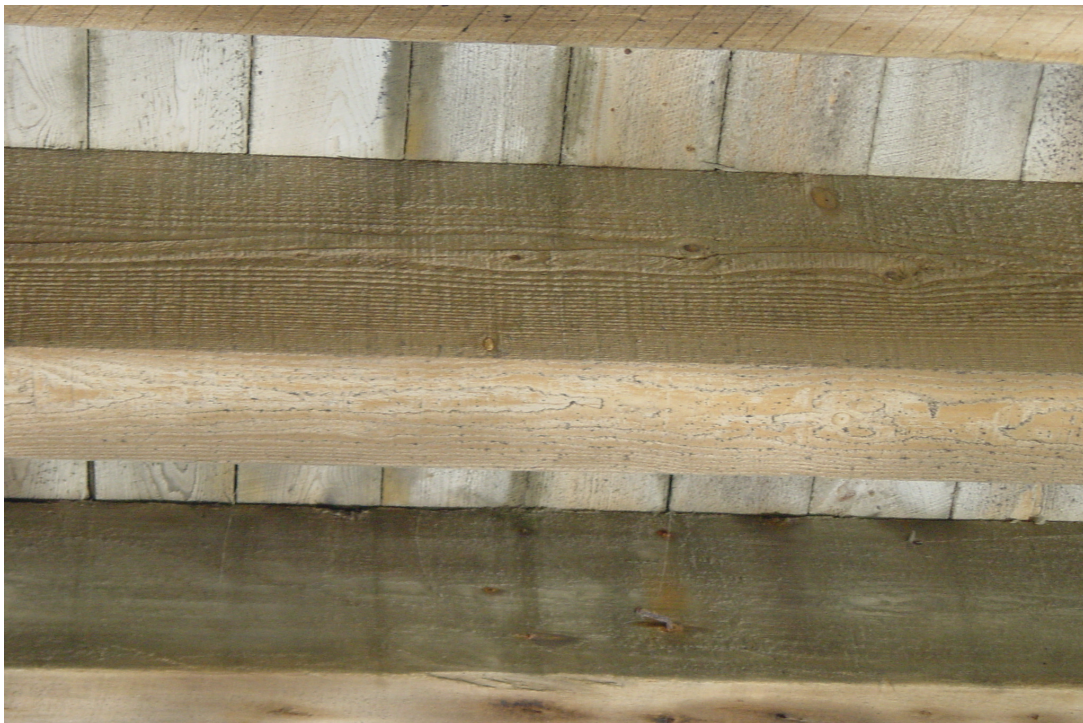
The new floor beams of 1987-88 appear to have been band-sawn on their sides, and cut to depth on a circular sawmill, leaving curved saw marks on their soffits, as seen below:

**Bottom: re-used floor beam. Middle and top: band-sawn floor beams sawn to depth on a circular saw**

Further discussion of future treatments of the Bath Village Bridge must take into consideration the age and condition of the current floor system as well as the loading requirements for the bridge, the budget available for rehabilitation, and other factors. This report is intended to record initial observations made during an inspection of less than a day. If work of an extensive nature is proposed for this bridge, further detailed study of the fabric of the structure will be required in order to place engineers' recommendations within the context of the historical integrity of the structure.
